November 5, 2020
CiS No.: 20103d-i

Re: **Garage Inspection & Structural Evaluation**
Home of Kellen Brumstead & Katie Mason
Property Located At: 40 Kingsland Terrace (Burlington VT)

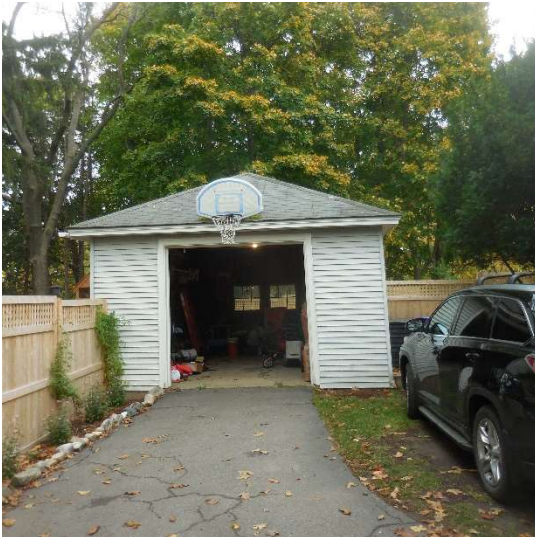
The garage is a single story, wood framed structure supported on, what appears to be, a combination grade wall/grade slab foundation system. The wood framed superstructure appears to be in good condition and structurally sound, with little to no evidence of distress and/or deterioration other than some minor wracking (structural lean) to the left/west. The wracking (PHOTO 1) has caused the garage door opening to be skewed to the west so that it may be difficult to install a fully functional, fully operable garage door without first pulling the garage structure back into place; an effort that would be futile unless the foundation system is repaired and/or replaced (see below).

PHOTO 1: South Side - Note slight wracking of building to the left (west) side

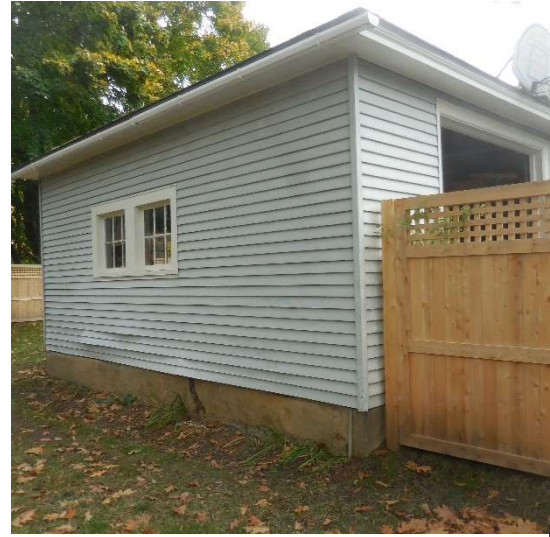
Unlike the superstructure, the grade slab/grade wall foundation system is in extremely poor condition with evidence of severe cracking of the slab (and vertical displacement of abutting slab sections – PHOTOS 3 & 4) and a severe vertical crack (with significant lateral separation – PHOTOS 2 & 4) in the exposed section of grade wall, supporting the west side of the building. The slab cracking and displacement are significant enough so as to discourage use of the garage for anything other than general, non-vehicle, storage. In addition to slab cracking/vertical displacement and the grade wall crack, it appears that the west side of the building has settled; a condition that most likely caused the building to wrack towards the west (noted above) and that caused damage to (buckling of) some of the siding on the west wall (PHOTO 2).

Damage to the slab/grade wall appears to be attributable to two primary factors: a foundation depth that does not extend below frost line (allowing structure to heave and settle in response to ground frost) and the apparent lack of any reinforcement of either slab or grade wall.

PHOTO 2: West Side - Note buckled siding and vertical crack in foundation/slab

Unfortunately, there is no reasonable, economical way to repair the garage slab and/or grade wall “in place”. As a result, both the slab and grade wall should be replaced with a proper, Code compliant, slab and foundation system; a foundation system (frost walls and footings) that is reinforced with steel and that extends down below the seasonal frost line. The slab could then be cast separate from the foundation walls and allowed to “float” on the soil below. The slab may or may not have to be reinforced depending on quality of the bearing soils. Although there may be several alternatives for constructing the new slab and foundation system, it seems that the most likely process would be to lift (jack) and temporarily move the existing wood framed structure before demolishing existing foundation elements and constructing the new foundation. The building could then be moved back into place and properly anchored to the new foundation.

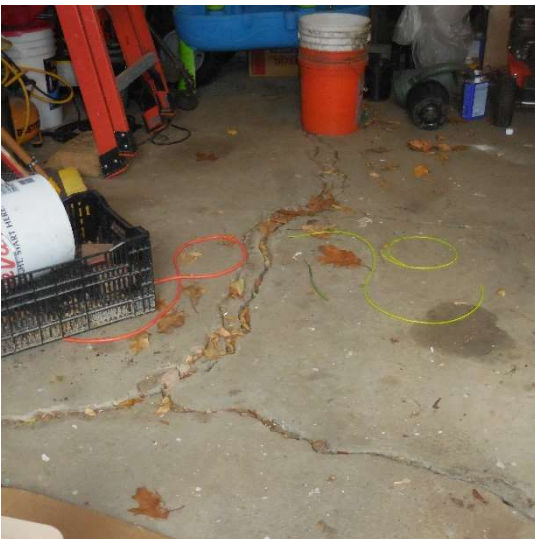
PHOTO 2: Slab - note extensive cracking and vertical displacement

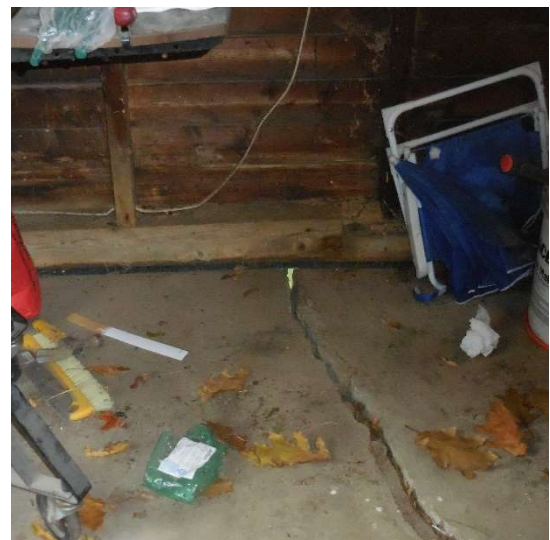
PHOTO 4: Slab - Note width of crack and visible daylight at end of crack where it becomes the foundation on west side
